# 1997-2025

## From Hold the Line to Adaptive Management

**A History of the East Head Coastal Issues Advisory Group**

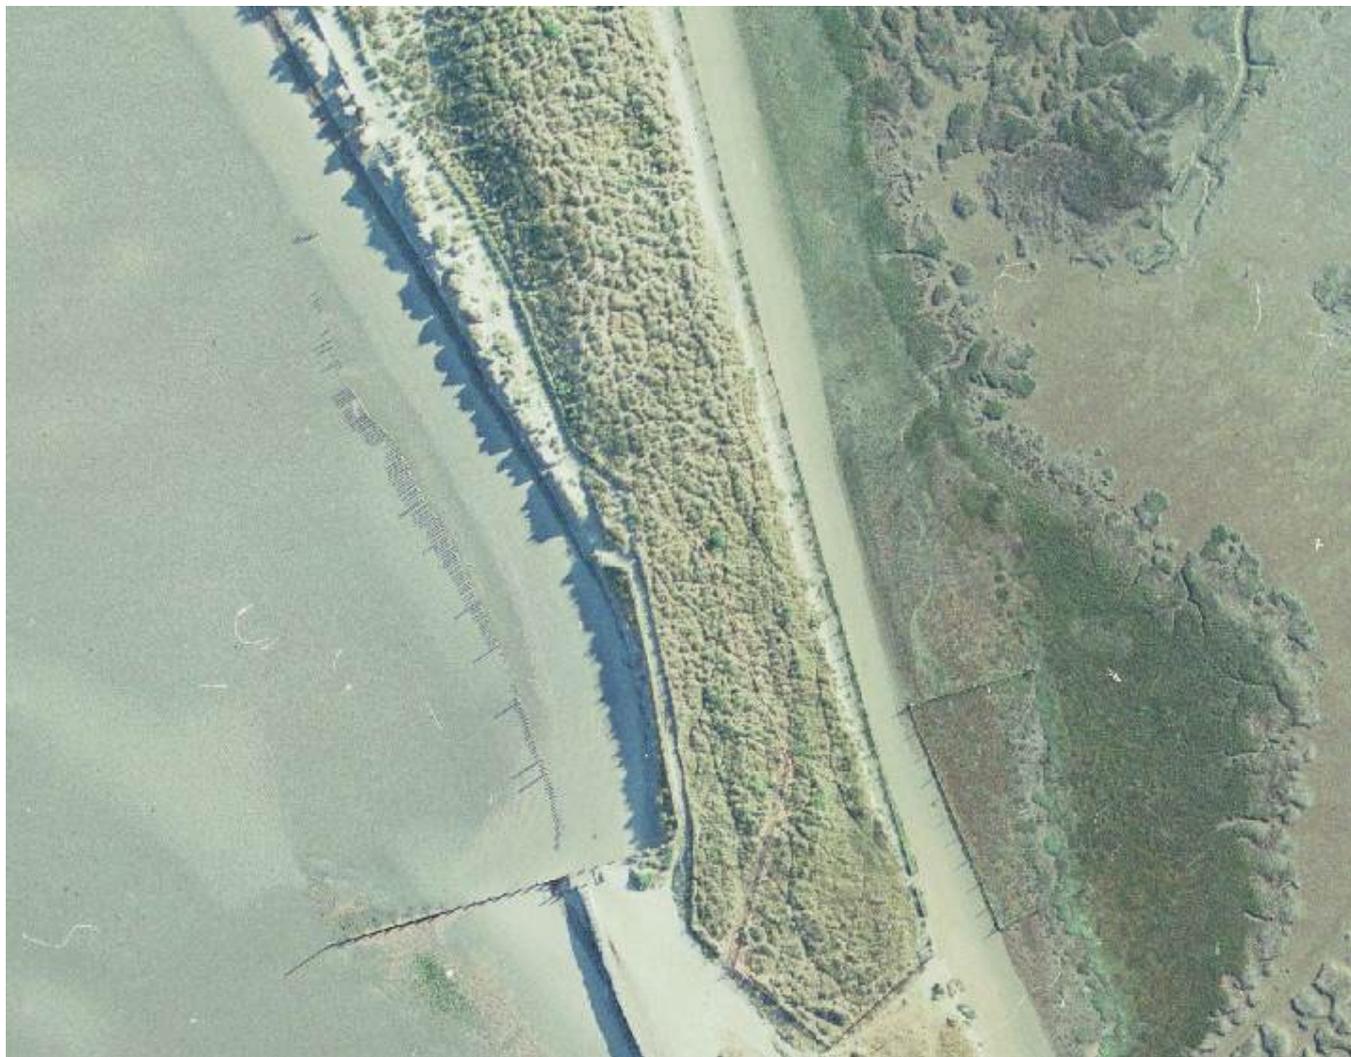
*Figure 4: Aerial photography of the dune just north of groyne C24 on 15 July 1999 showing an erosion scarp on the western side.*

During 1998/9, at the time the PEHCDS-1 was first being discussed, significant narrowing of East Head immediately north of the last groyne (C24, see Figure 3) at “The Neck”, gave rise to serious concerns of a tidal breach. Chichester Harbour Conservancy (CHC), with support from others sought planning permission to install a rock berm with a maximum height of 2.8m above Ordnance datum or 700mm above MHWs on the Snow Hill Creek side of the spit.

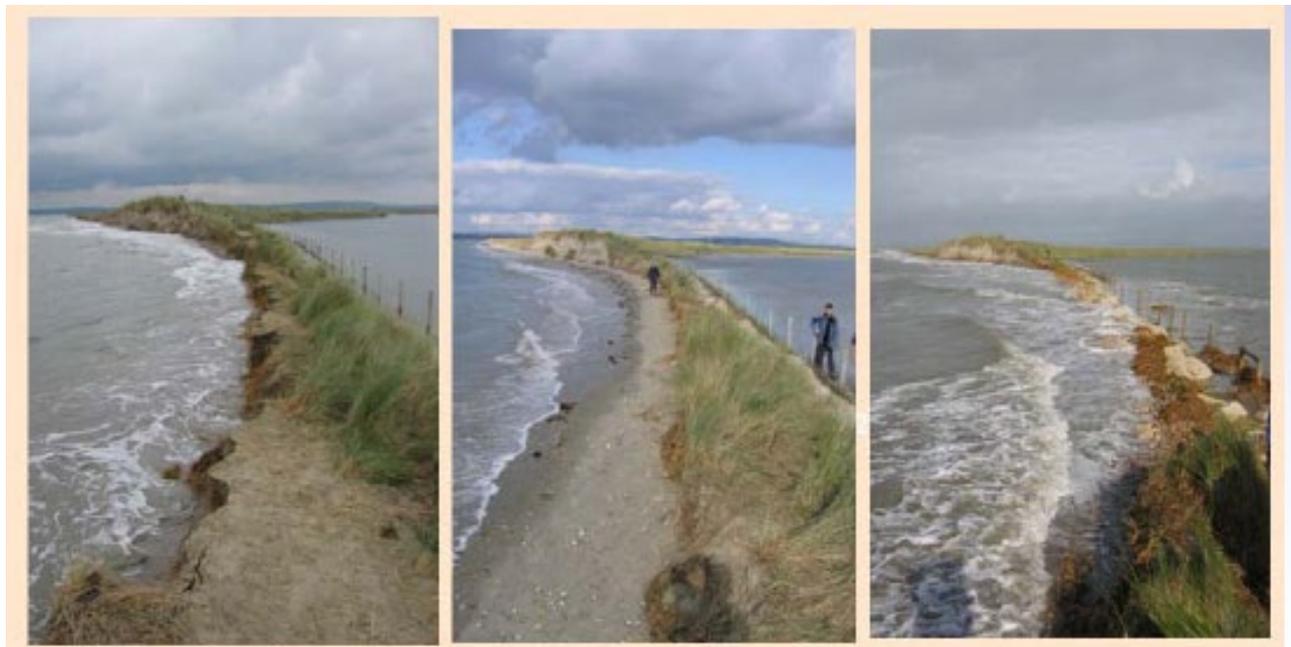
15<sup>th</sup> October 2004

18<sup>th</sup> October 2004

28<sup>th</sup> October 2004

*Figure 5: Photographs of rapid changes that occurred at “The Neck”. Note the water level on the landward side. Photos were taken at high tide.*

The neck continued to narrow and in October 2004 the spit and berm were overwashed (Figure 5). There was no indication that a tidal breach was threatened as the rock berm was only overwashed at high tide to a maximum depth of about 500mm and the wave energy was quickly dissipated by the still water in Snow Hill Creek. As a result, an overwash fan quickly developed (Figure 6) as the transport capacity of waves declined and the sediment settled out. In the following weeks the fan on the east side of the berm began to build up through both wind-borne sand deposits and occasional overwashing waves.

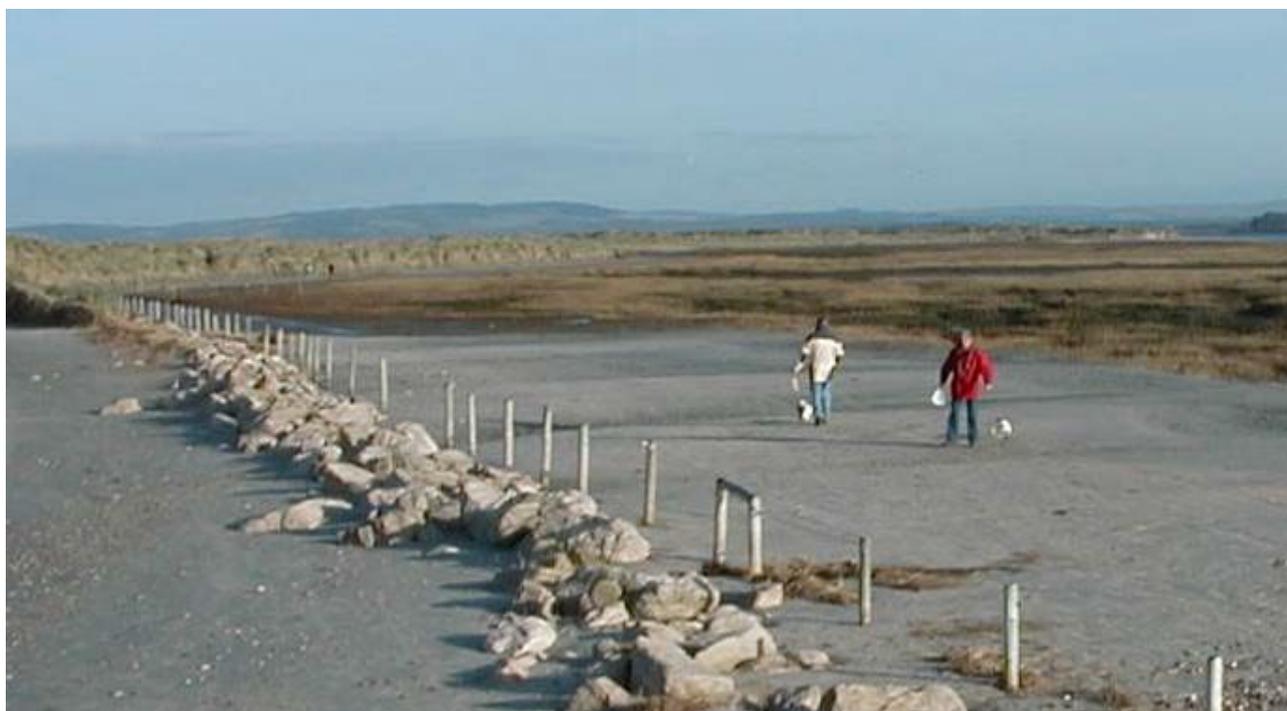
*Figure 6: Overwash fan created by waves losing momentum and dropping sediment when they met the still waters of Snow hill Creek. Photo taken just before works were undertaken in March 2005.*

It was recognised that this situation was delicately balanced, and a proposal was put forward to build up the overwash fan and upper foreshore over the rock berm with material taken from the north end of East Head. The planning conditions attached to permission made it clear that continued monitoring of the volume of sediment replenishment at the donor site would be required.

All parties of the EHWG agreed to this action and in March 2005 some 13000 tonnes (about 7,200 m<sup>3</sup>) of material, mainly sand with some shingle, was placed in the area of the overwashing. There was discussion over whether marram grass should be planted to “stabilise” the freshly deposited material, and National Trust undertook some minor planting of relocated marram grass plugs on both the seaward and harbour sides of the access path located along the top of the deposited material. Natural England accepted the planting that had been done but would not sanction further attempts to fix the dune in place with further planting because the mobility of the sand dune system is a feature of both the SSSI and SAC.

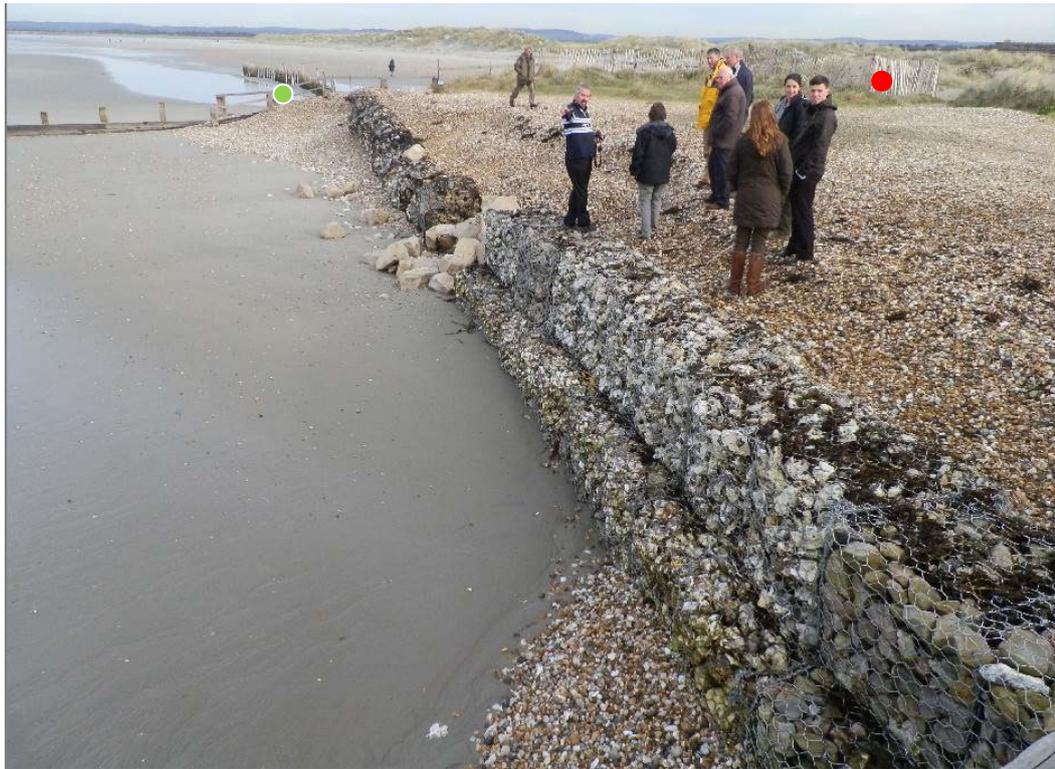
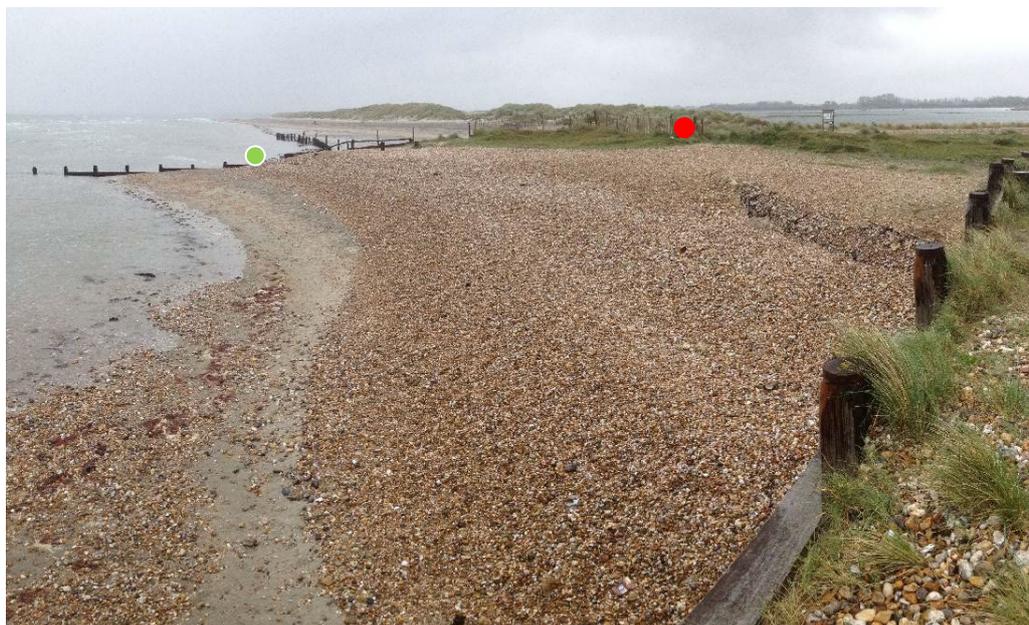
*Figure 7: Area between groynes C23 and C24; top November 2013, bottom November 2014. Red and green dots show corresponding locations in both photos.*

Monitoring continued and when the gabions between C23 and C24 failed over the northern half in 2013 they were removed. Contrary to expectation from some that the beach would retreat rapidly the frontage was managed by removing planks from updrift groynes, C22 and C23 and increasing the

height of C24, the beach actually relaxed into a gentle slope which was able to absorb wave energy better than the gabions.

When the Northern portion of the gabions failed there was no hesitation and they were removed. Even during the severe winter storms of 2013/14 this groyne bay showed few signs of distress (Figure 7).

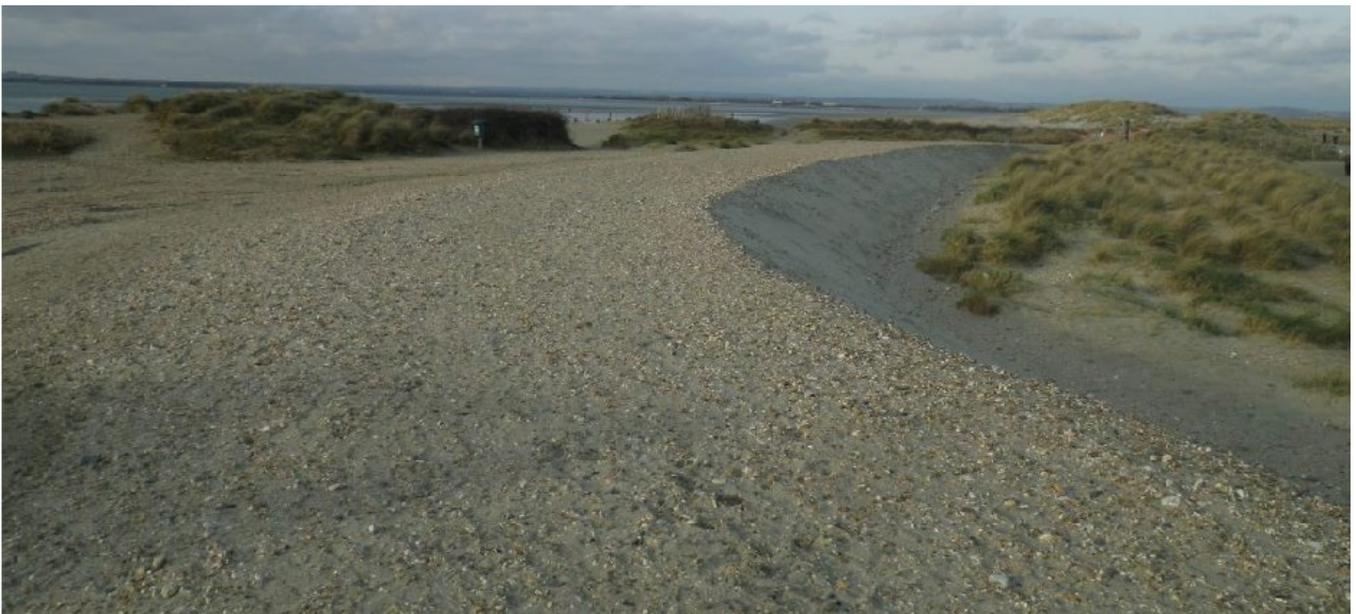
*Figure 8: View north along the newly placed sand and shingle bund, 4 February 2016.*

The response to the exhibition was positive and supportive and the Group felt encouraged to proceed with the next steps. To provide additional reassurance that when the breastwork finally fails and the tamarisk ridge rolls back a project to build up the sediment store behind the Hinge was initiated at the end of 2014 which was implemented in early 2016 when 2,000 tonnes (~1,100 m<sup>3</sup>) of sand and shingle taken from the tip of East Head were placed along a stretch of bare surface (see green polygon in Figure 3). This provided reassurance to allow for the removal of temporary repairs of the breast work to take place and the process of beach evolution to proceed. The cost of £16000 was covered by contributions from group members

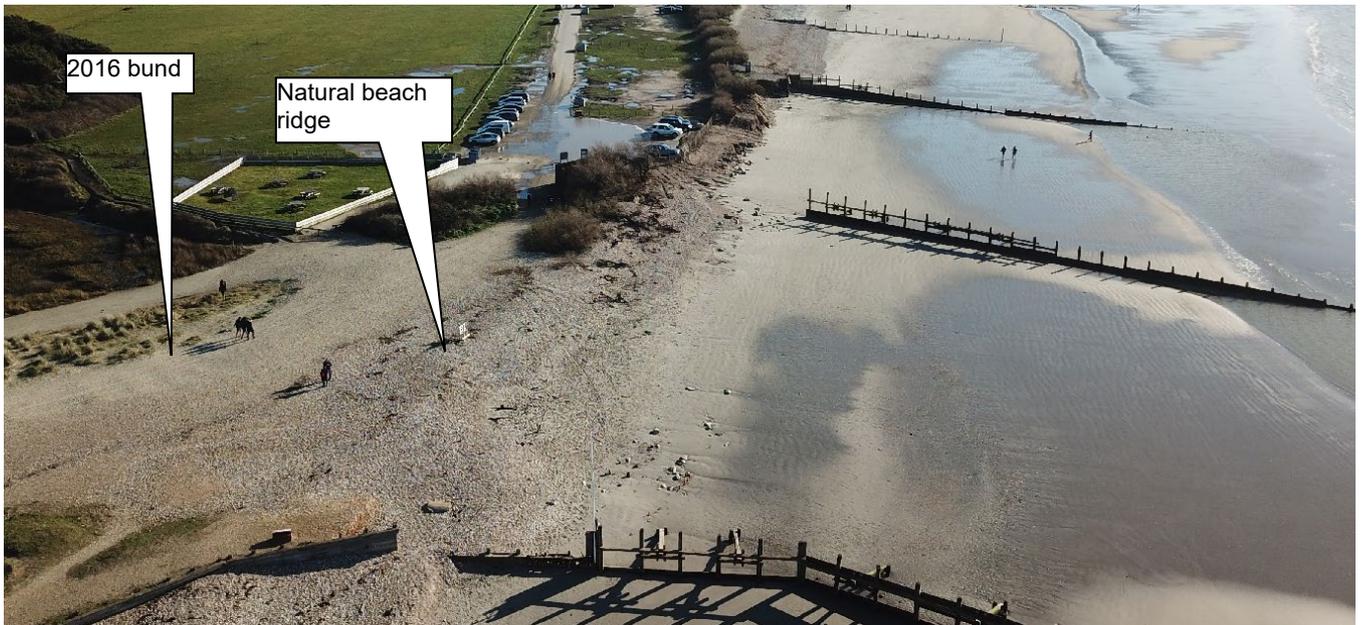
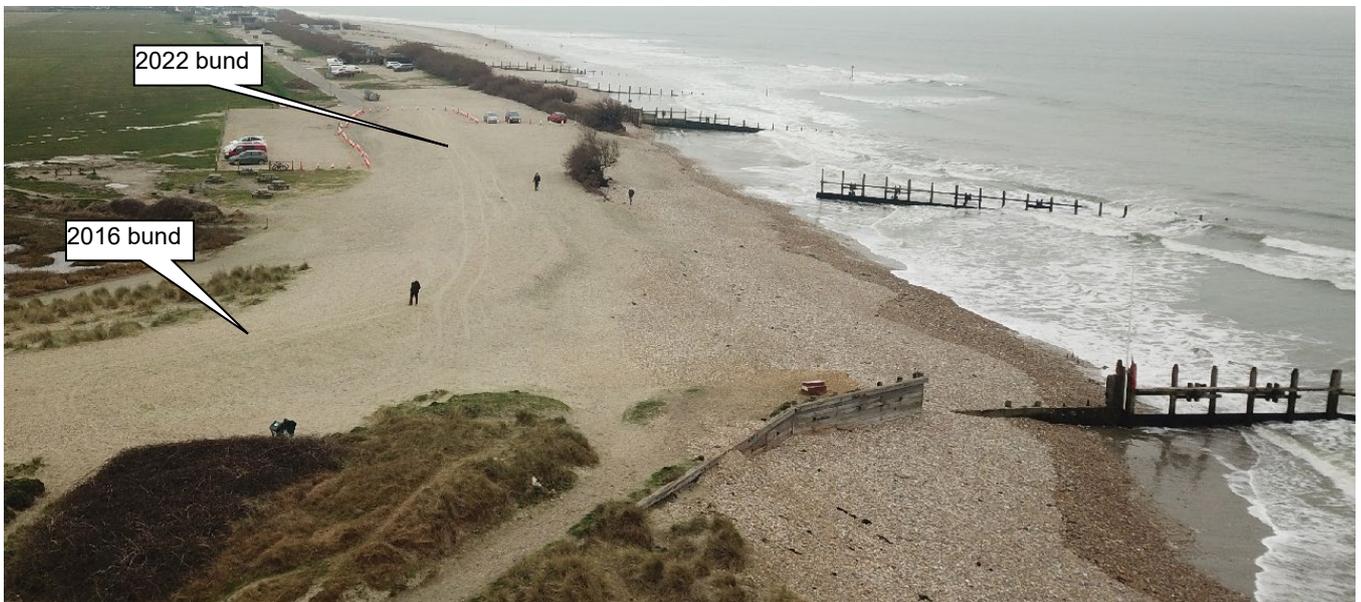
*Figure 10: Top: Removed breastwork between groynes 22 and 20 (25-01-2021) with impact on the car park area. Bottom: the new 2022 beach bund with relocated car park area and open access to East Head*

Removal of failing breastwork followed a pattern of lowering to allow the beach to move landwards and eventually removing of piles to form a continuous beach (Figure 9). By 2021 the beach had reformed in front of the 2016 beach bund and the removal of timber between groyne 21 and 20 started to impact the car park area (Figure 10). Following the success of the 2016 beach bund another recycling campaign from East Head brought beach material to build the 2022 bund with associated relocation of the car park. As the land rises from The Hinge eastwards, the 2022 bund feathered into the higher ground at 3 mOD (Figure 11) which is sufficient to maintain any flood risk into Chichester Harbour. The last section of timber breastwork was removed in spring 2022.

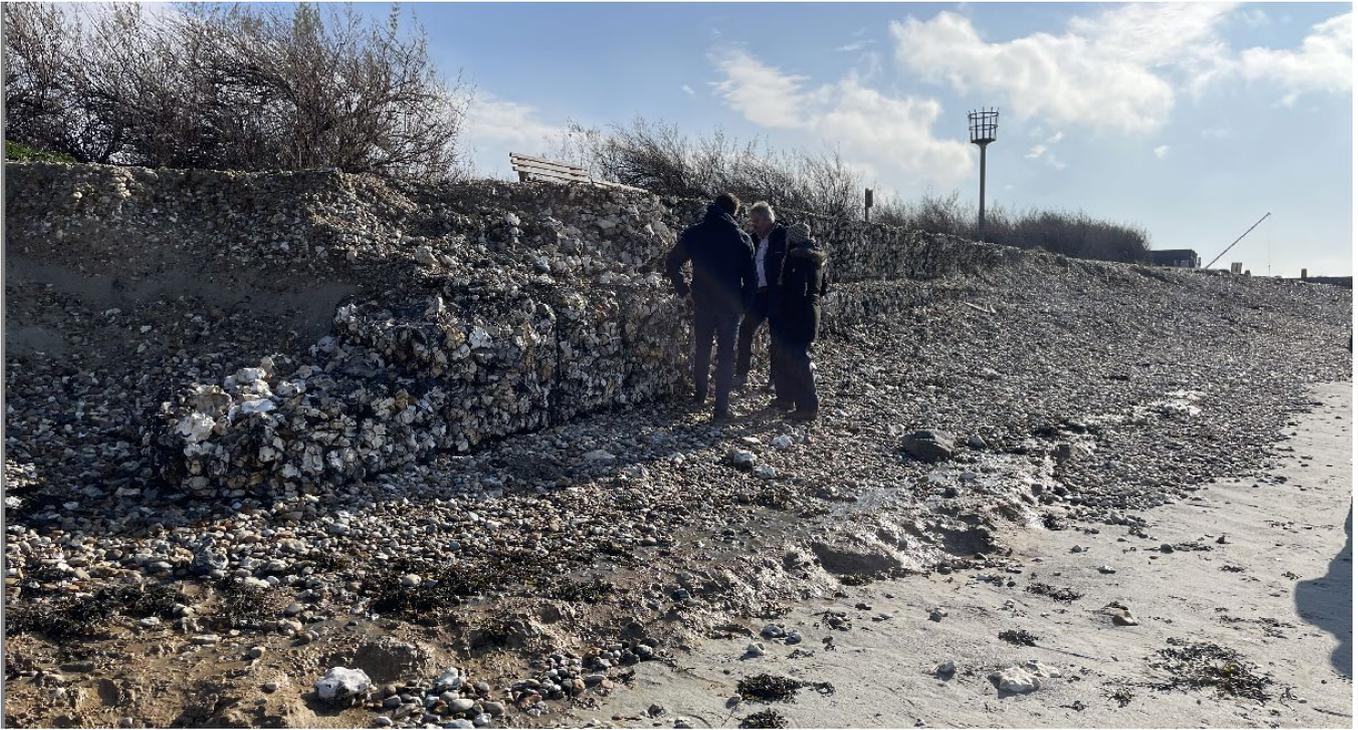
*Figure 11 Gabion wall east of groyne 20 on 07-03-2024 located on the brown and grey clay substrate. The flint in the gabions are a welcome addition to the beach. David Lowsley at his last EHCIAG 8 years after his retirement.*

East of groyne 20 the timber breastwork changes to an approximately 2 m high wall of gabions, and being exposed to the abrasion of moving shingle and corrosion of the steel basket these have started to fail and have been gradually removed over the last three years up to towards groyne 19,

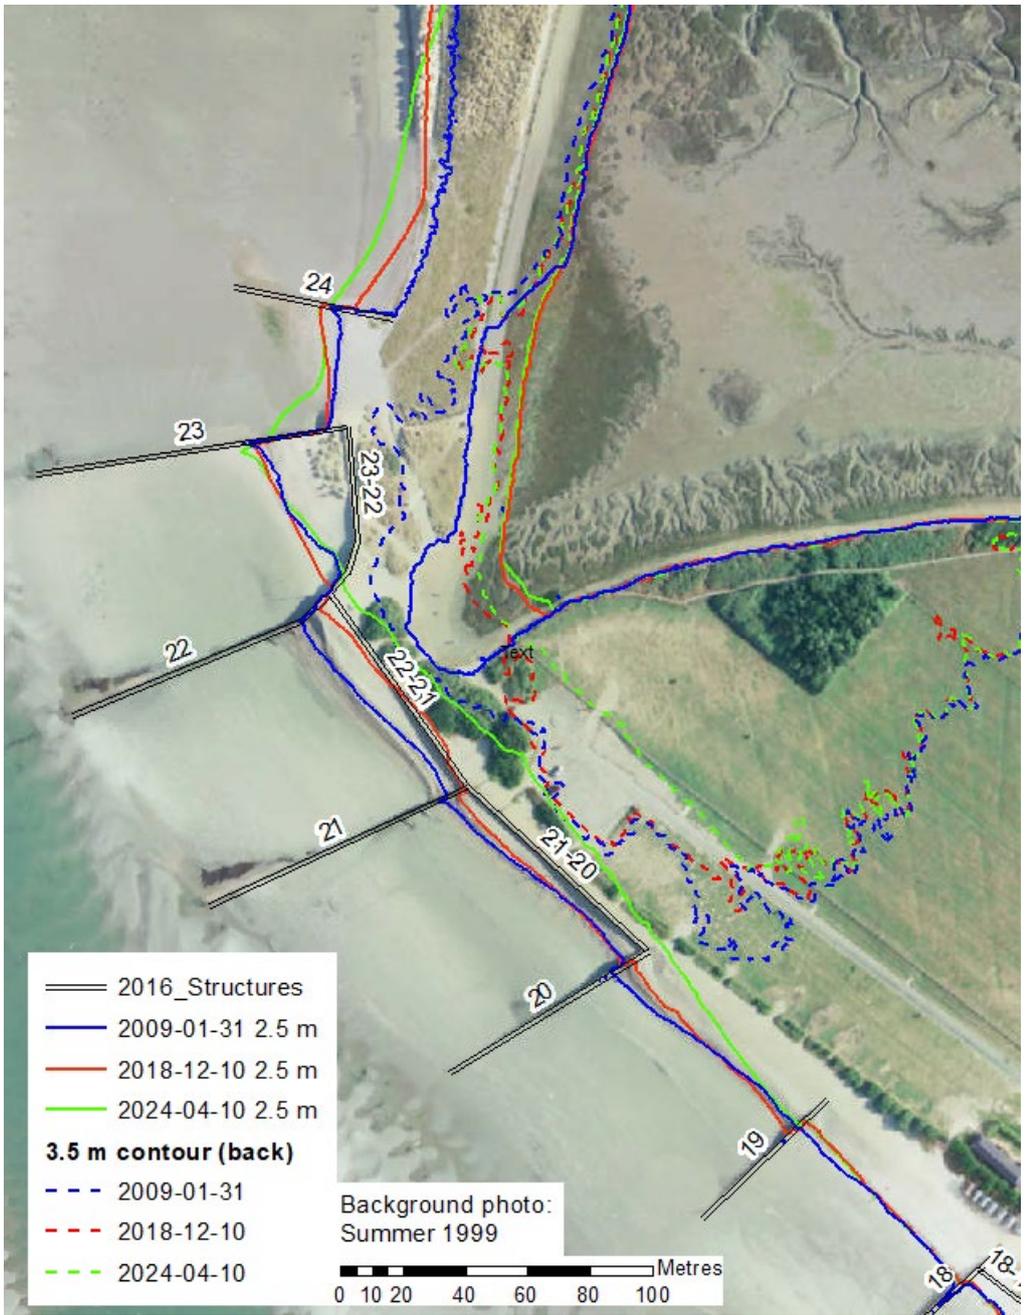
Figure 12: Overview of changes over 25 years from 1999 to 2024 illustrating the managed roll back by maintaining the width between the 2.5 m contour on the seawards side and the 3.5 m contour on the landward side.

Figure 12 provides an overview of the more recent changes using contour lines using 2.5 mOD at the seaward and landward side together with the 3 mOD at the landward side only. It shows that at the Hinge the distance between the seaward 2.5 m and landward 3.5 m contours in 2009 was 20 metres, and that the distance in 2024 has increased to 30 metres despite the seaward contour having moved landwards. The same can be seen further east across the car park area following the recharge to create the beach bund in 2022.
